Kashiwa Tech Co., Ltd.

**Subject : Experimental test on lithium-ion-battery-powered vehicle fires with
outside air high-expansion foam fire-extinguishing system**

1. Date: The experimental test is conducted upon October 28th, 2022 (Friday).
2. Venue: Shirosato Test Center / Japan Automobile Research Institute (JARI)
3. Purpose:

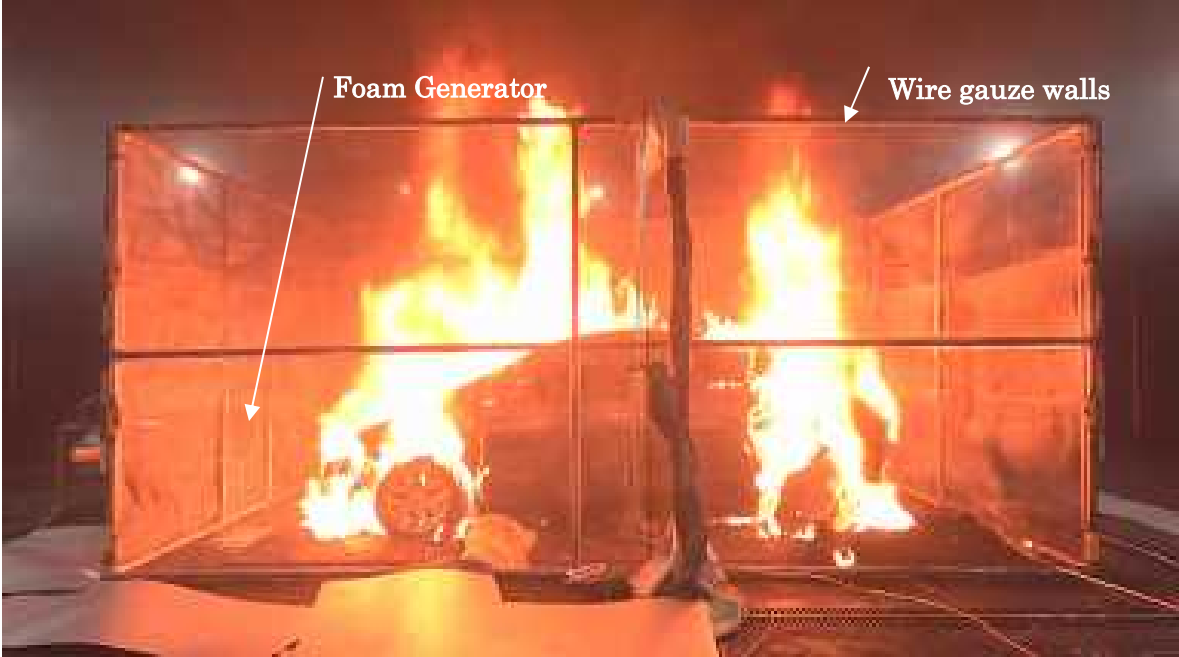
Figure 2: Test vehicle on intensified fire

The high expansion foam was then discharged (Figure 3) when the fire was most intensified enough to cover the test vehicle with flames (Figure 2).

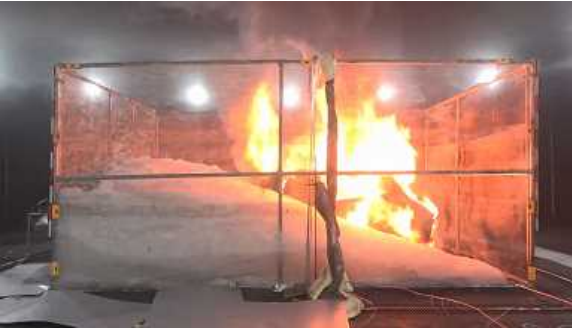
Figure 3: Test vehicle submerged in foam

The foam started building up in the area and covering the burning vehicle and controlled the fire.

The foam discharge was stopped when the accumulated foam reached the top edge of the surrounding wall 8 minutes after the start, though the foam then partly disappeared due to the heat from the fire.

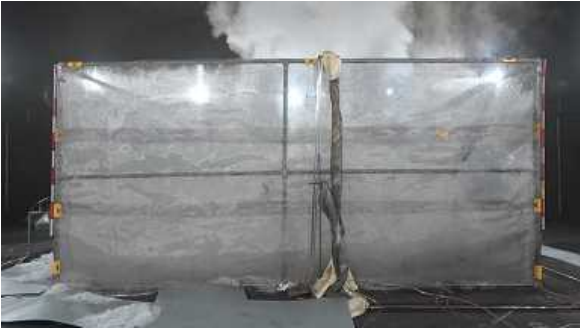
Figure 4: Smoke and gasses generated

Generation of smoke and some gasses were observed from the test vehicle in the foam (Figure 4). Steam the smoke and the gasses is supposed to be steam vaped from the moisture of the foam and the gasified electrolyte leaked from LIB, due to heat from the test vehicle.

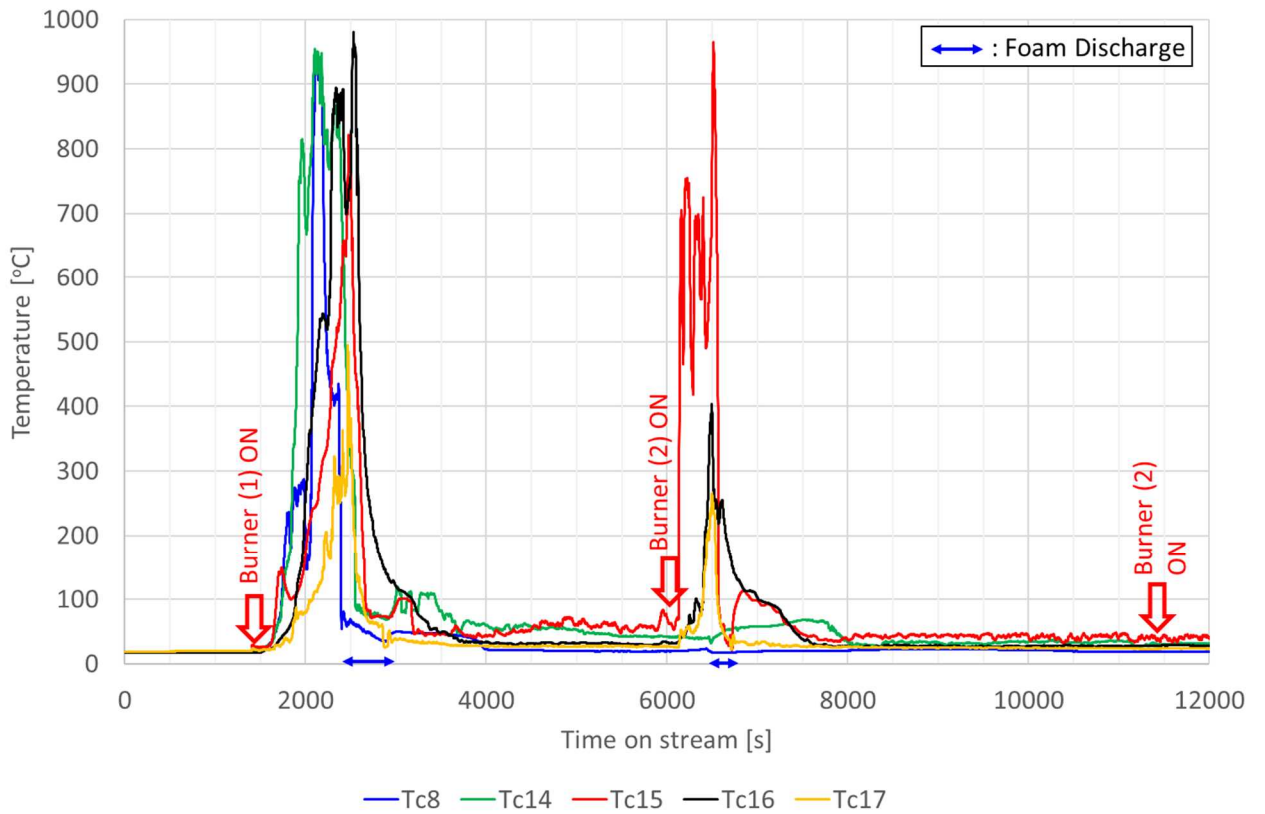
Graph 1 Temperatures on the test vehicle

Graph 1 and Graph 2 show the temperature changes in relation to time at each measurement point.
